## How Much Is Too Much

The following was taken from an existing condition monitoring account at Perot Systems in Dallas Texas.

The equipment was one of three 1100 ton built up BAC Prichard cooling tower cells with Amarillo model 135 double reduction gear reducers and 60" jackshafts. Permanent accelerometers were mounted on gear reducers h e to accessibility. Baseline data was taken and frequencies inputted into database. An outside contractor had replaced the hot deck section and some structural supports. Several weeks later a considerable in overall velocity at the gearbox in the axial direction was noticed. An increase from .24in/sec to .40in/sec. Velocity spectrum data showed 1 X motor input frequency at .38in/sec. Phase data was taken and showed 180° shift across jackshaft in both the axial and radial positions. Misalignment as well as some couple unbalance were apparent. Laser alignment was performed and motor feet repined. A couple balance was then done and overall dropped to .22in/sec. At this point our phase data was unstable and erratic. New collection route was taken and a current alarm noted. Our high frequency trend and envelope also went into alarm from .4gse to 5.9

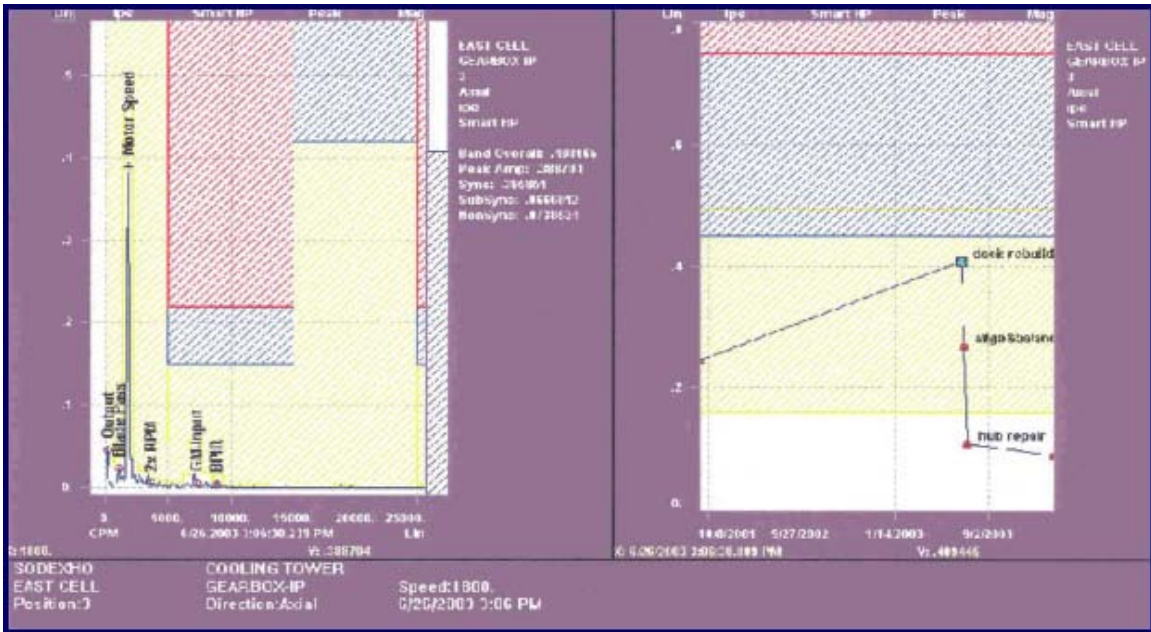
Magnitude trend shows velocity increase from .2in/sec. to .408in/sec. after deck and structure replacement. Spectrum shows input speed dominant from .22in/sec. to .38in/sec.

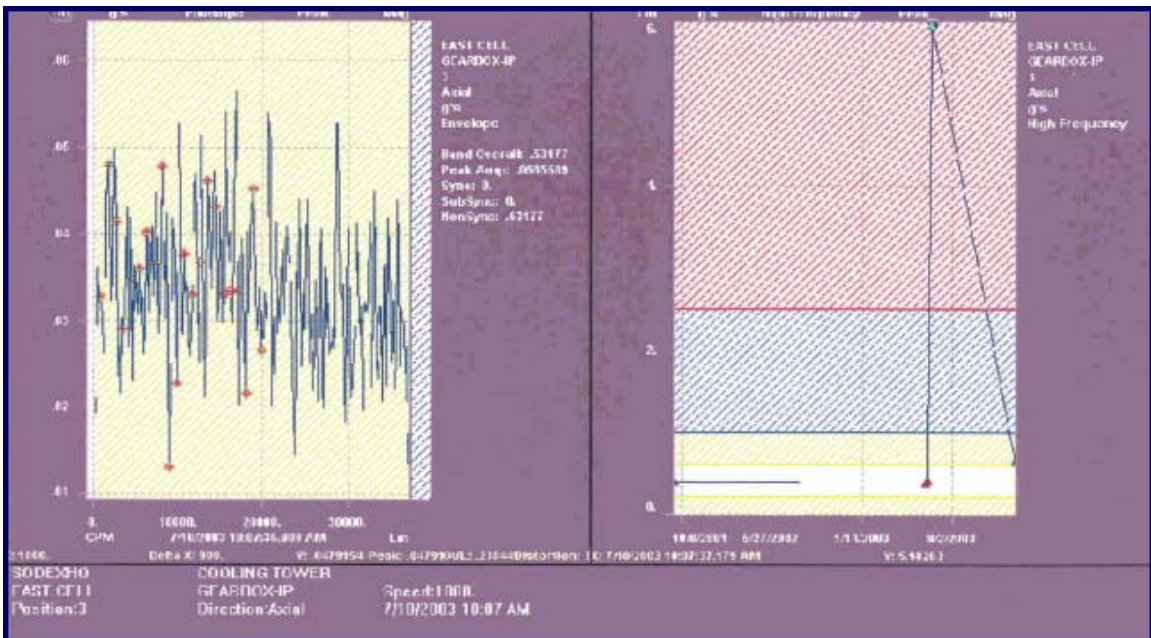
High frequency trend showed increase from .3gse to 5.9gse and triggered alarm. Envelope spectrum showed input speed and harmonic impacts as well as 1/2X sub harmonics.

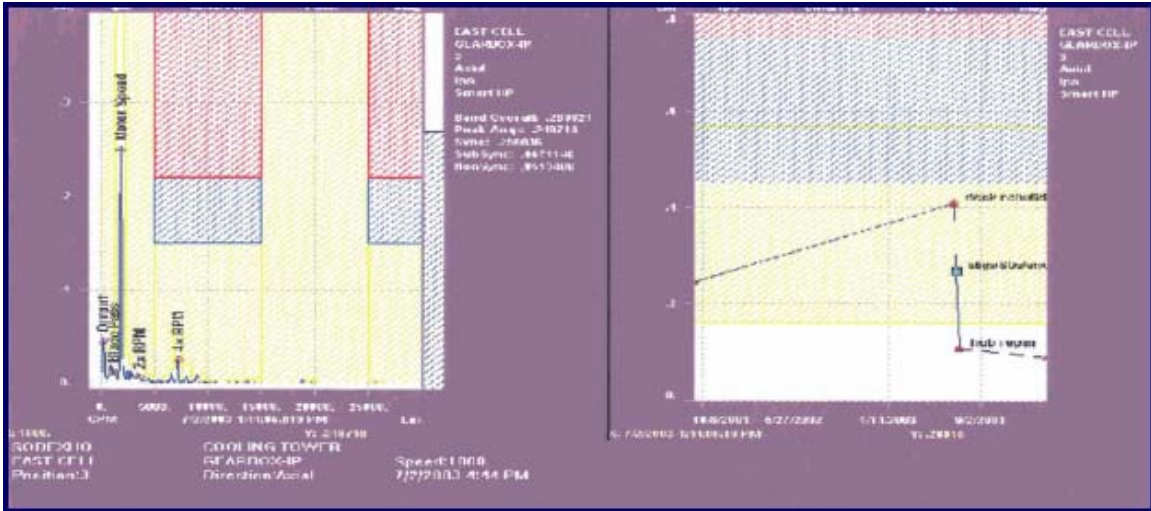
After laser alignment and couple balance dropped from .4in/sec. to .26in/sec. overall. Input speed dominant at .24in/sec. from .38in/sec. Spectrum showing input harmonics increased. Looseness present.

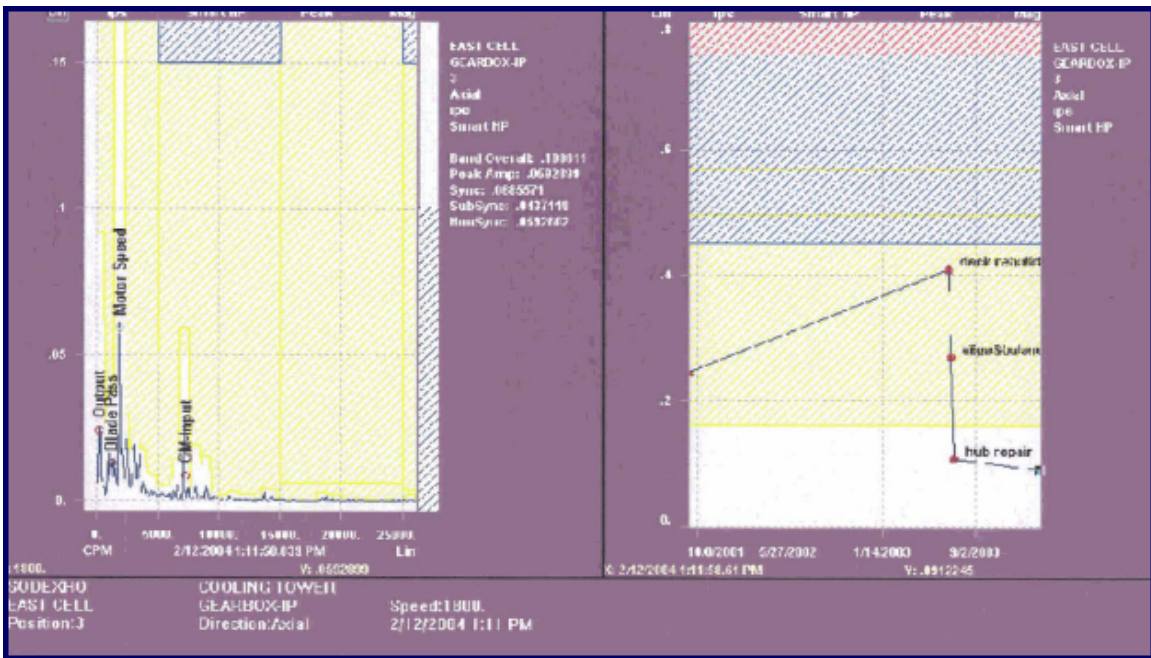
After shaft yoke repair velocity magnitude down to .09in/sec. Spectrum shows input speed down from .38in/sec. to .05in/sec. GM-Input appears after close coinciding 4X input harmonic went down.

The yoke was re-machined to a machine fit and bushing retainers installed. Jackshaft was then trim balanced to standard and new collection taken. Final data showed velocity readings down to .09in/sec. overall with input frequency at .06in/sec. High frequency data was down out of alarm at .6gse.
